**Docket No. 217 – Development and Management Plan Inspection**

**Date:** December 16, 2004

**Location:** Norwalk Substation Expansion

**Location:** Plumtree Substation Expansion , Bethel

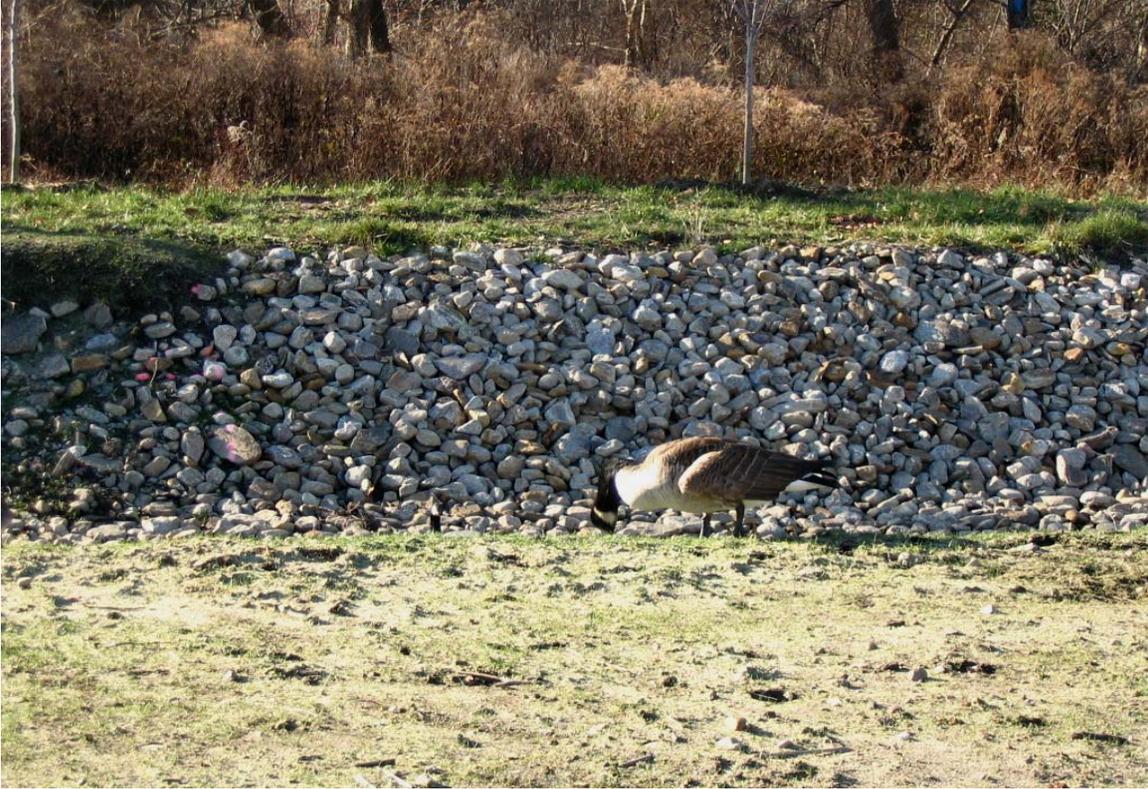
Silt fence has been removed from the vegetated area across the overflow channel and the area appears stabilized. The wildlife in the area is helping to inhibit further grass growth! 12/16/04

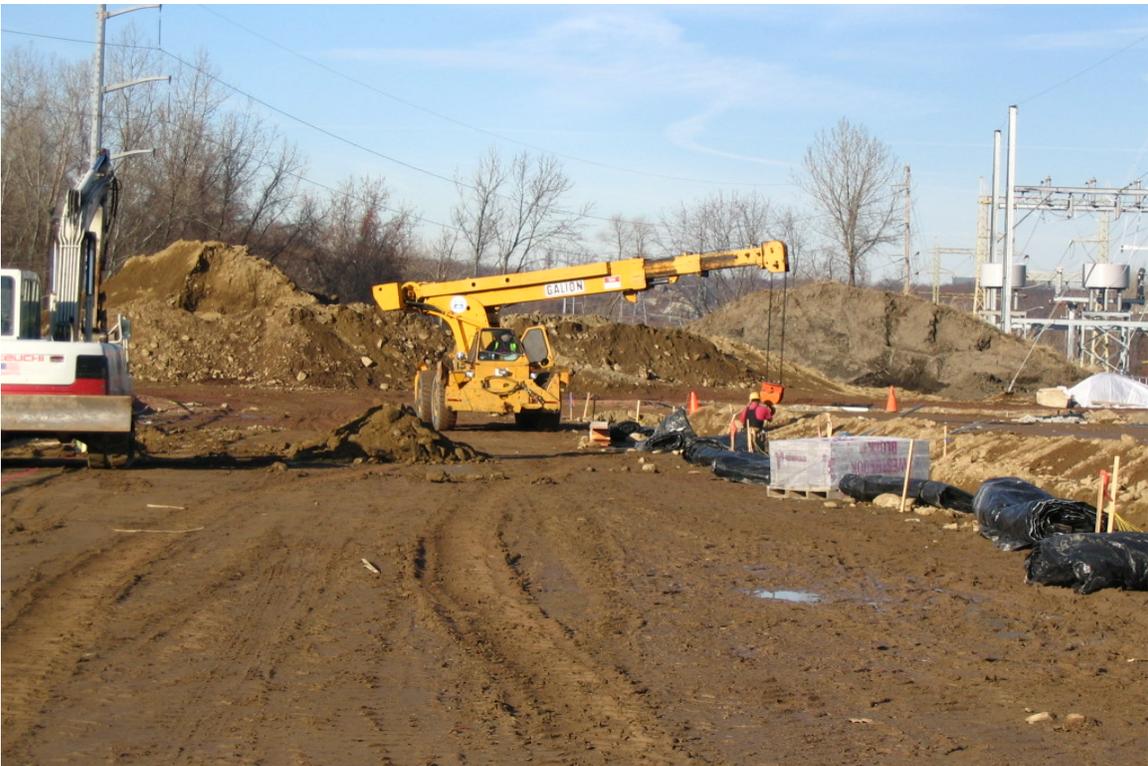
Stockpiling continues as a result of the ground grid excavation. All soil is well enclosed within the site within the inner retaining walls. 12/16/04

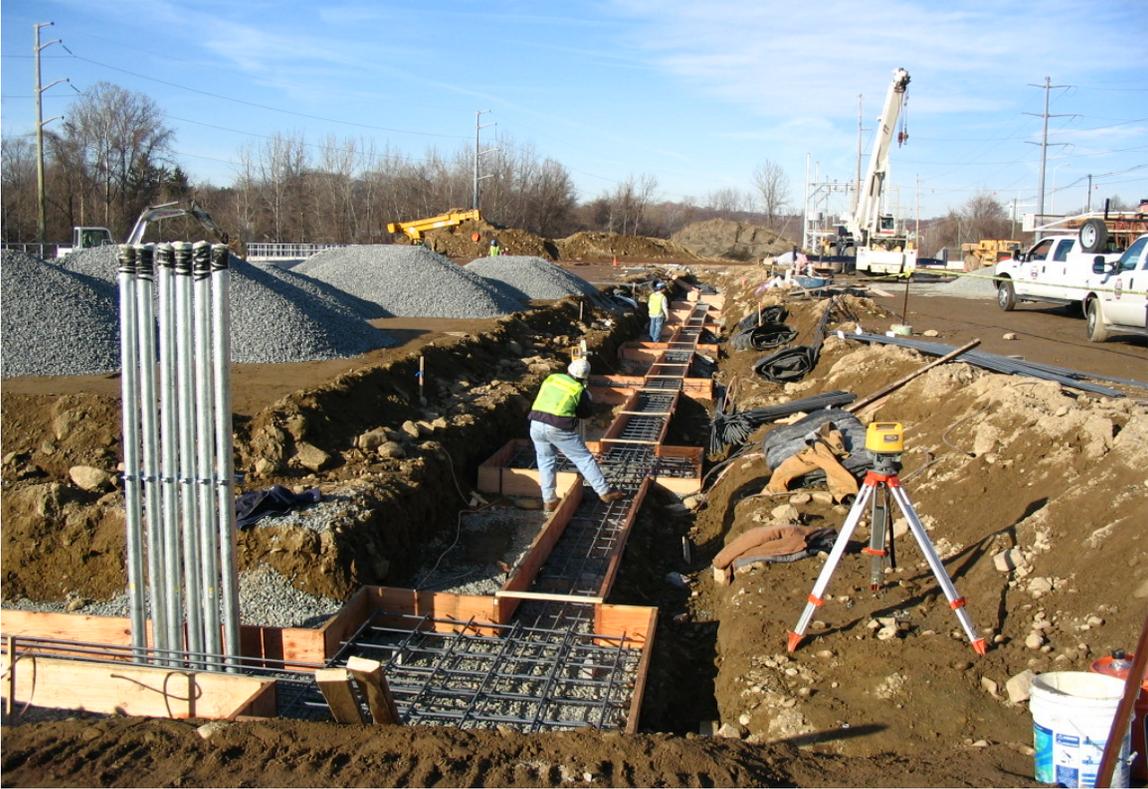
View of the excavation and further construction of the grounding grid for the GIS building.  
12/16/04

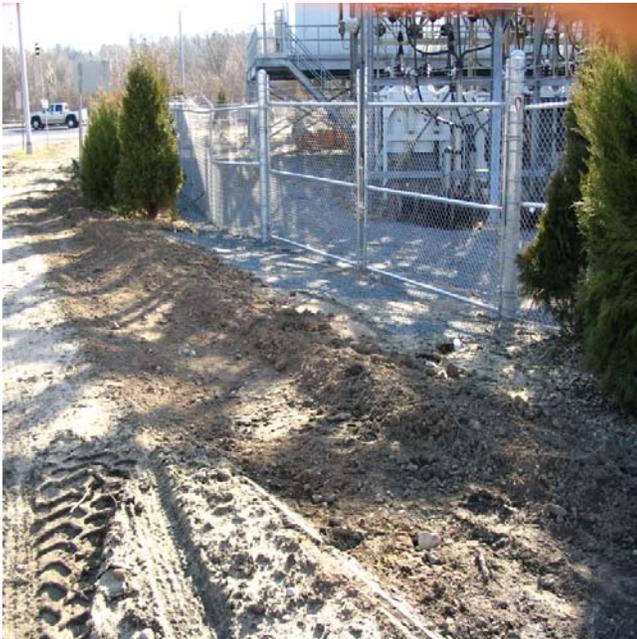
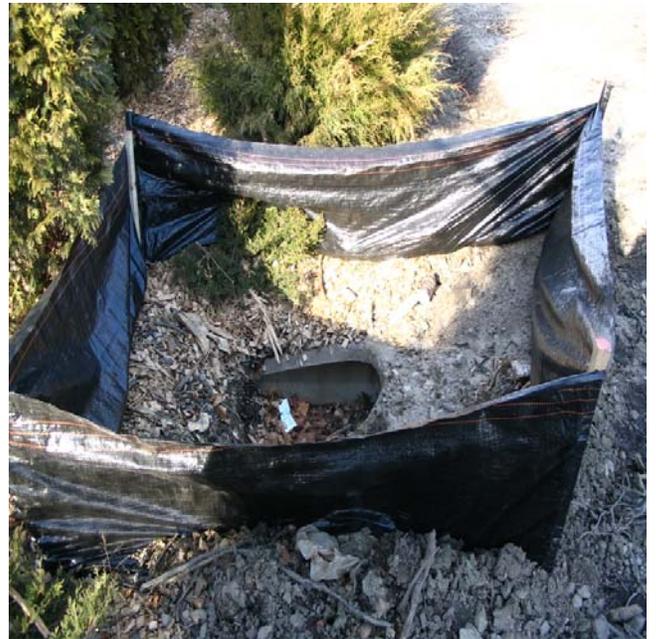
- The flared inlet near the Rt 7 ramp has been enclosed in silt fence to help filter stormwater runoff. 12/16/04	- Continue to monitor for effectiveness. 12/16/04

- Some gullies remain on the slopes of the ditch along the perimeter fence and Rt 7 ramp, but an earthen berm/swale has been constructed to better direct runoff. 12/16/04	- Monitor the swale for effectiveness during rain events and determine whether further stabilization is necessary. 12/16/04

The earthen swale/berm along the perimeter fence near the Route 7 ramp has been created to better direct stormwater run off from the ditch. The inlet has also been enclosed in silt fence.  
12/16/04

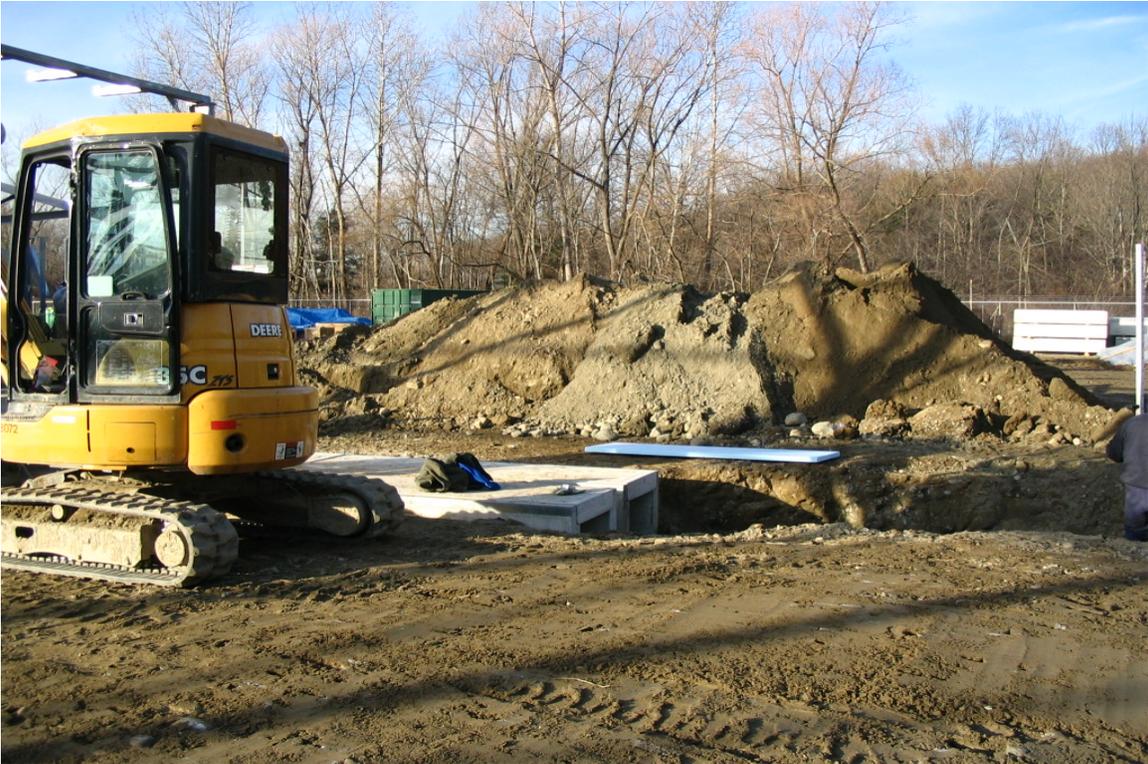
Plumtree Substation: Work continues on minor excavation/installation of cable trenches adjacent to the concrete slab. All stockpiles are well within the site. 12/16/04

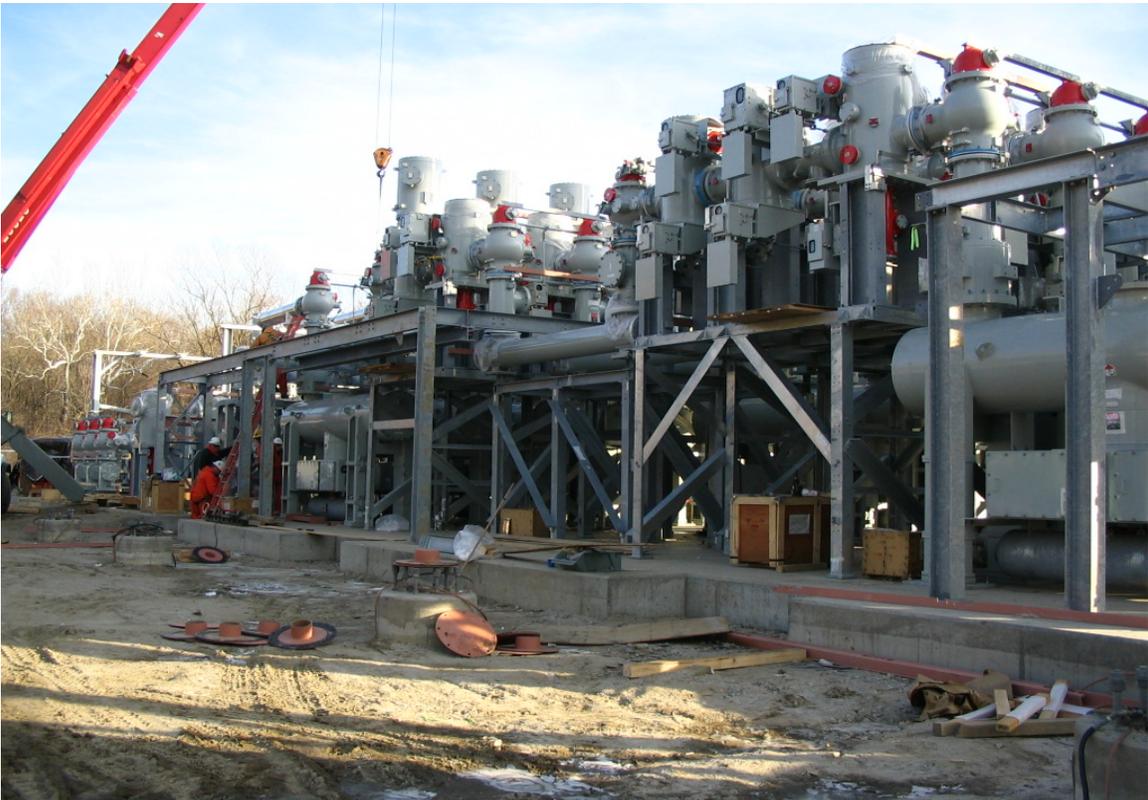
Work continues on construction and installation of the equipment on the concrete slab. 12/16/04
